Montoursville Area School District

District-Wide Facility Study

May 2020 **PROGRESS DRAFT**

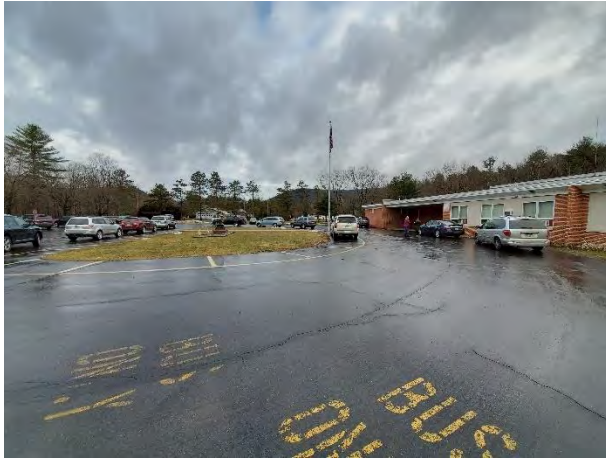
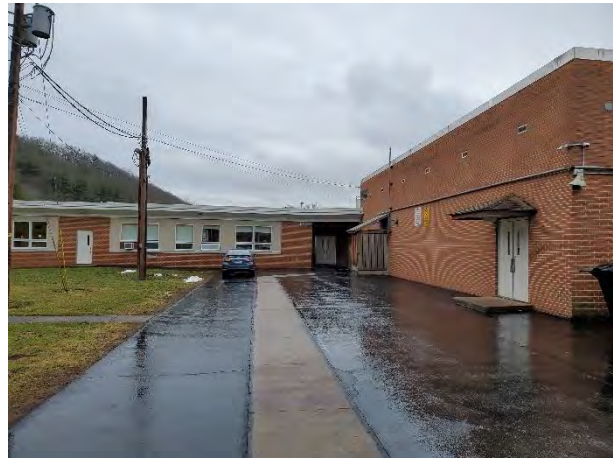
Paving & Walkways:

The drives and parking are bituminous material which are showing significant signs of wear and are in poor condition.

Walkways are and are in fair condition.

- Mill and Resurface all bituminous paving including hard surface play area.

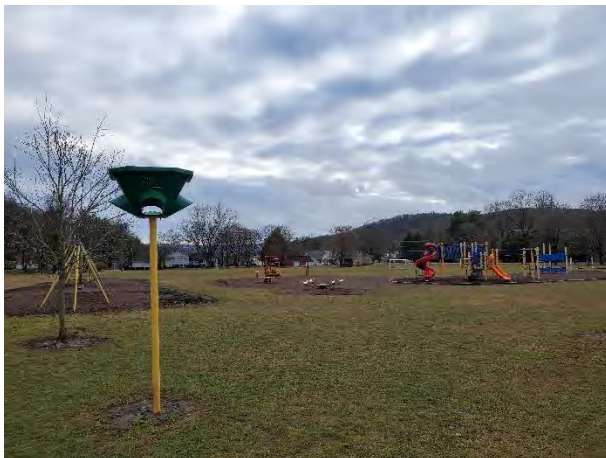
Play Areas & Equipment:

The hard surface playground is in poor condition. The playground equipment is in good to fair condition and should be re-evaluated in 5 years.

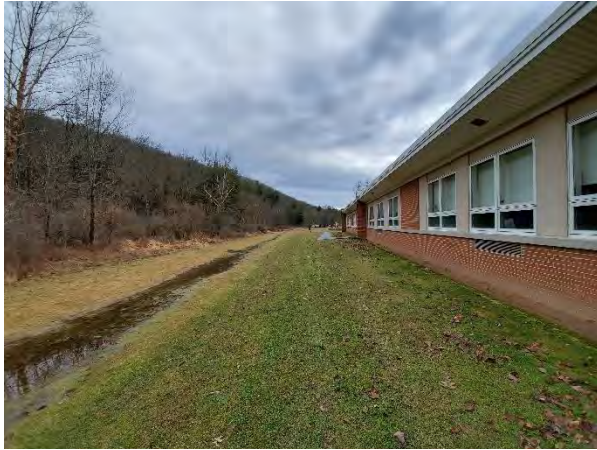
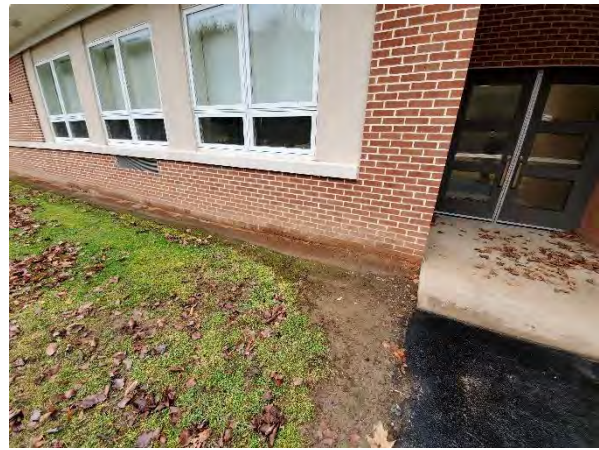
Exterior walls are comprised of brick and stucco. These materials are in fair condition.

Water infiltration is occurring in the below grade exterior walls of the water storage tank room.

Humidity issues have also been reported along the classrooms to the rear of the school (along the tree line). This could be due to exterior envelop integrity, adjacent ground water issues, building orientation, HVAC Systems, or a combination of two or more of these factors. A more in-depth analysis needs to occur to determine the exact cause of the humidity.

- Correct humidity issues in classrooms
- Replace exterior doors

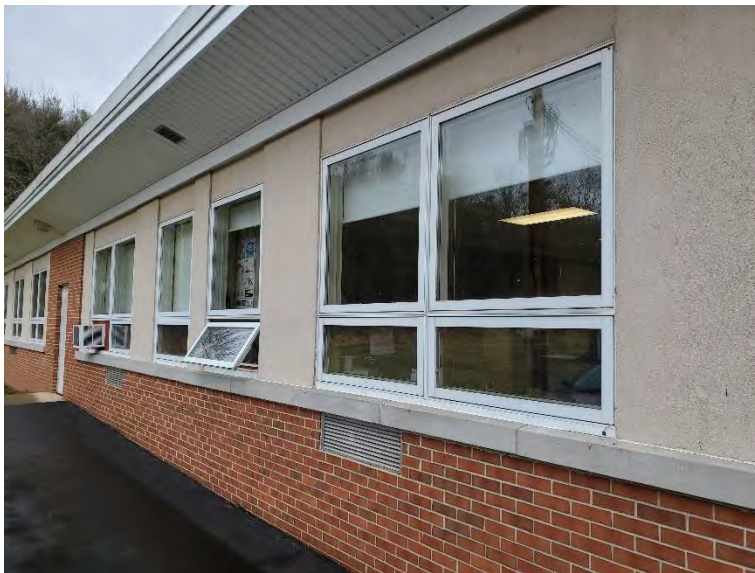
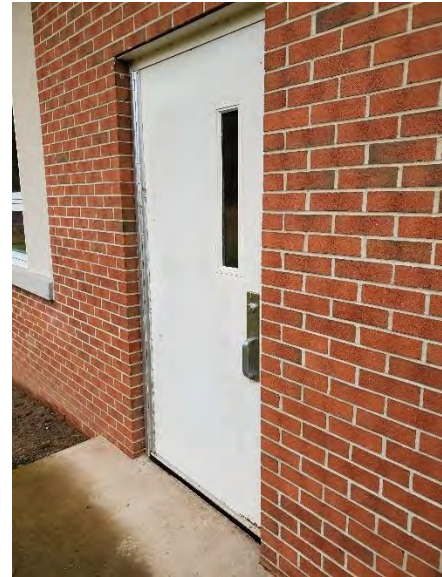
Doors & Windows:

Exterior doors are a combination of aluminum framed storefront with glazing and hollow metal. Aluminum frames are in fair condition. Hollow metal doors are in poor condition. Exterior windows are aluminum clad vinyl windows with insulated glazing. Windows are in fair condition and should be re-evaluated in 5 years.

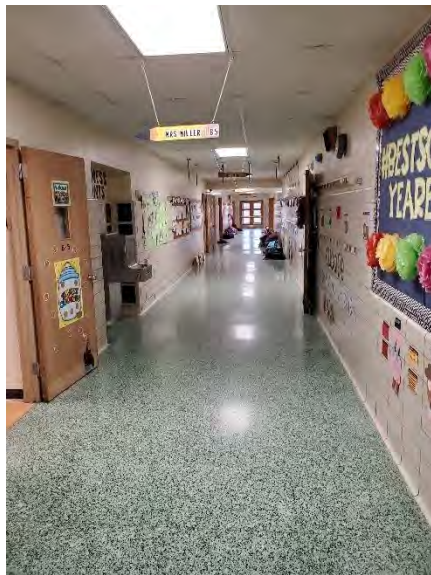
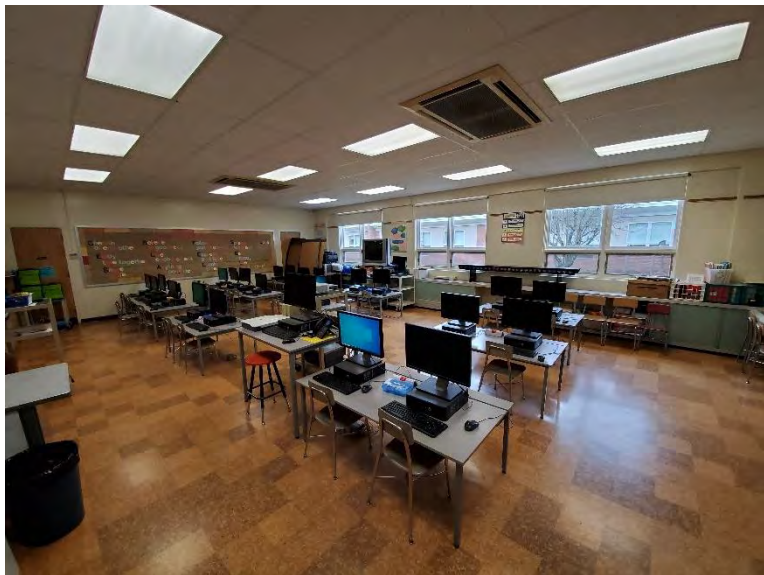
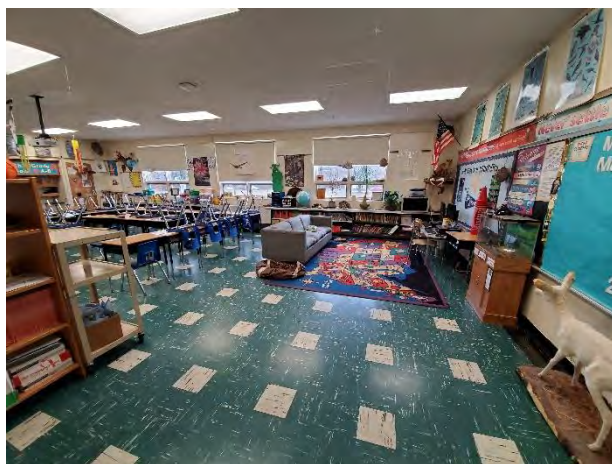
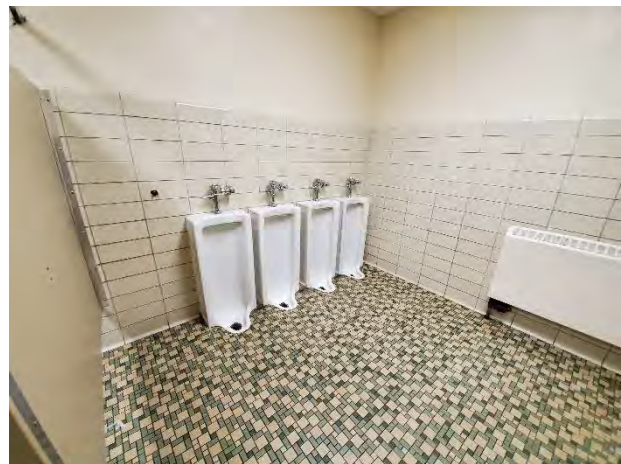
Interior walls consist of painted concrete masonry units, glazed masonry units, and painted plaster. Wall finishes are in fair to poor condition.

Floors consist of terrazzo, VCT, VAT, and ceramic tile, and carpet. Terrazzo floors and newly installed VCT is in good condition. VAT, ceramic tile, and carpeted floors are in poor condition.

Ceilings are primarily suspended ceiling tiles. Ceilings are in fair to poor condition. Recently replaced ceilings are in good condition.

- Install crawl space ventilation system.
- Patch/repair and paint interior plaster walls.
- Replace flooring except terrazzo and newly installed VCT.
- Replace all ceilings except newly installed ACT.
- Renovate/reconfigure toilet rooms.
- Replace interior doors and hardware.
- Replace classroom casework.
- Replace food service equipment
- Abate asbestos floor tile.

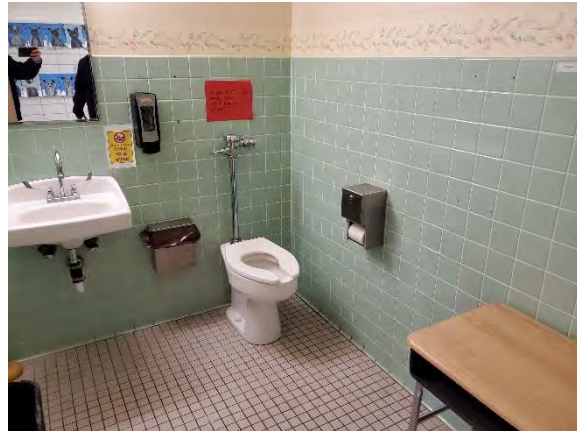
Toilet Rooms:

Toilet rooms do not meet current accessibility standards and are generally in poor condition.

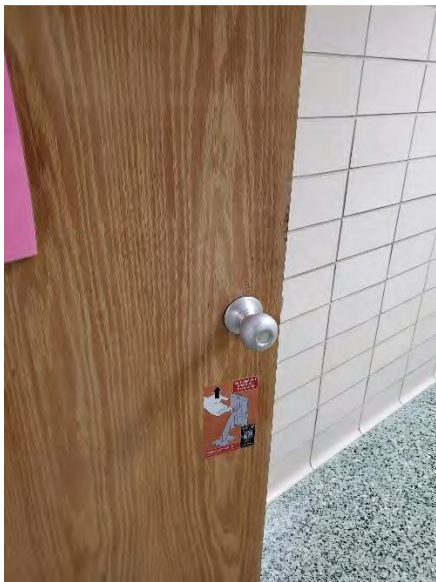
Doors:

Doors are primarily solid wood core with aluminum frames. Doors are in fair to poor condition. Door hardware is in poor condition and the majority do not meet current codes.

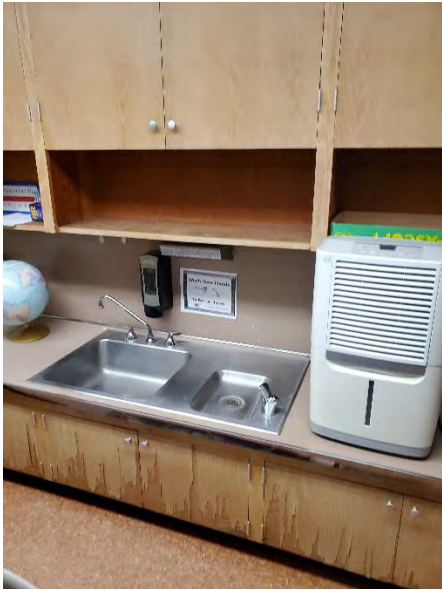
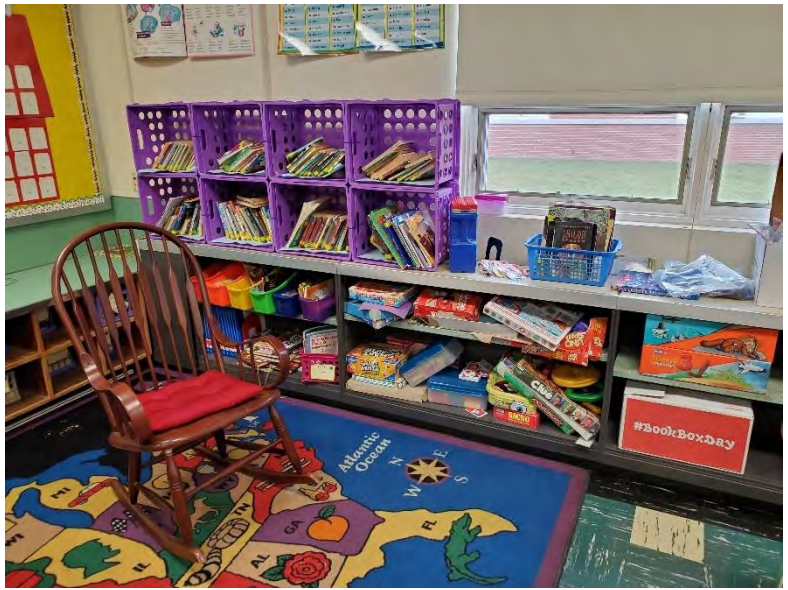
Casework & Built-in Equipment:

Casework is a combination of plastic laminate and metal. The plastic laminate is delaminating from the majority of the surfaces and the metal casework is in poor condition.

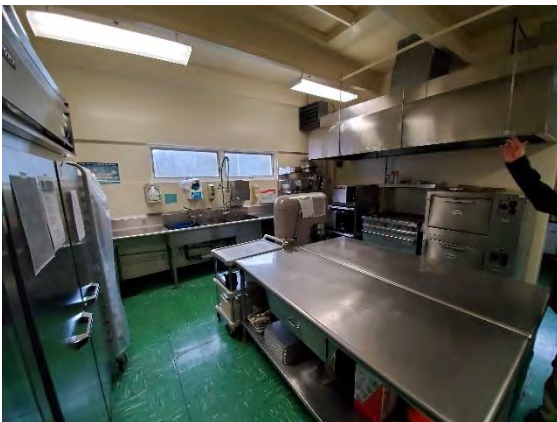
Specialty Equipment:

Food service equipment is outdated, in poor condition, and not functional for today's standards. The stage rigging and curtains are in fair condition.

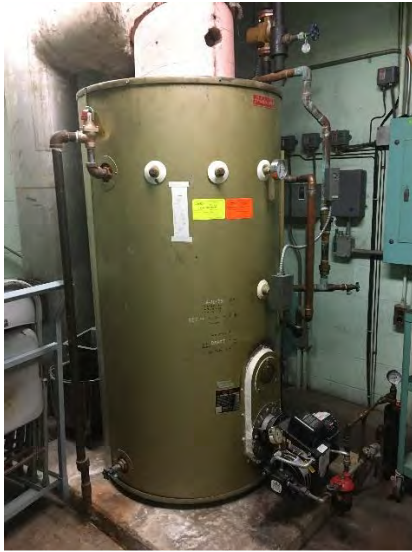
The existing water heater is an oil-fired tank type heater with approximately 80 gallons of storage. The oil burner was recently replaced. A circulator pump circulates hot water throughout the building. The pump is not on a time clock.

Oil fired water heater

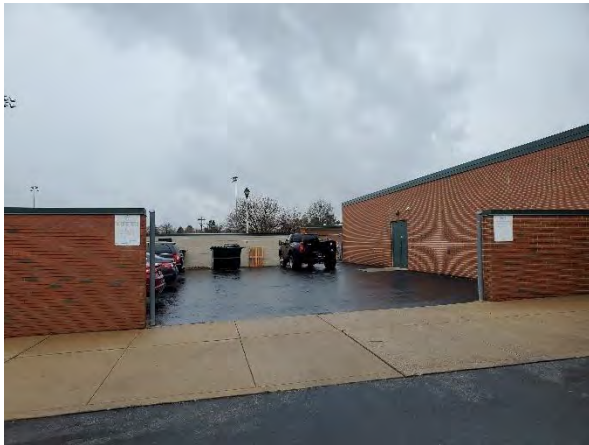
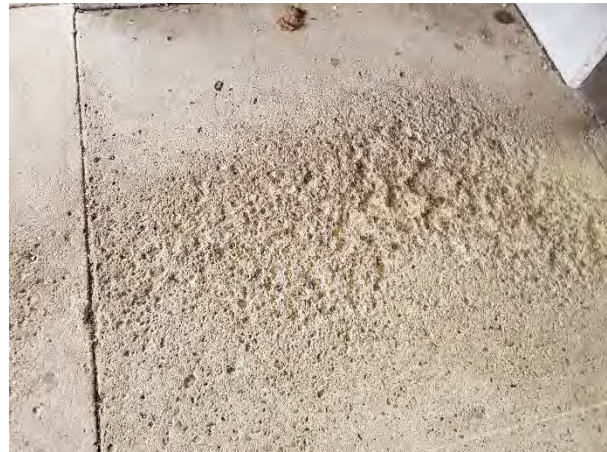
Paving & Walkways:

Paving for parking and drive is bituminous and is in fair condition. Sidewalks are concrete in fair to poor condition. Sidewalks in the front of the building are deteriorating.

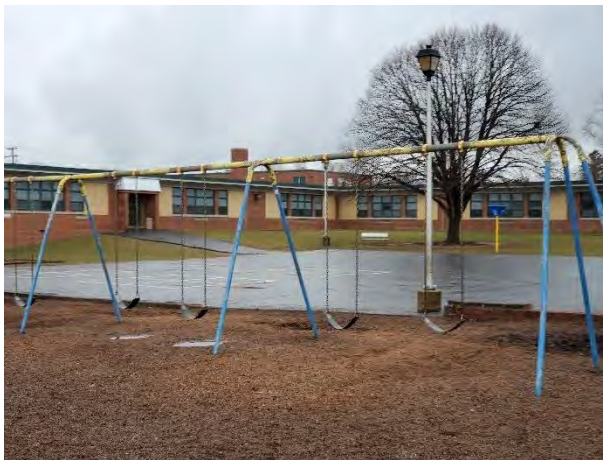
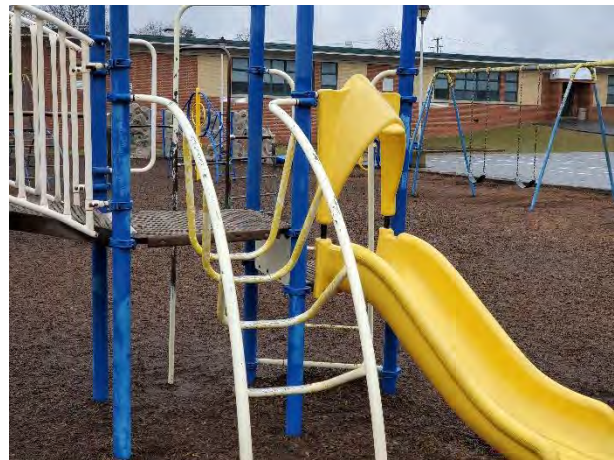
Play Areas & Equipment:

The ballfields on the property are in good to fair condition. The hard surface play area is bituminous and in fair condition. Both are in need of ongoing maintenance. The playground equipment is outdated and nearing the end of its useful life.

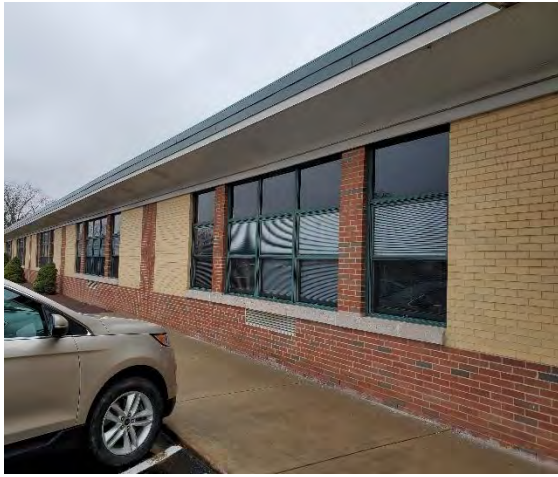
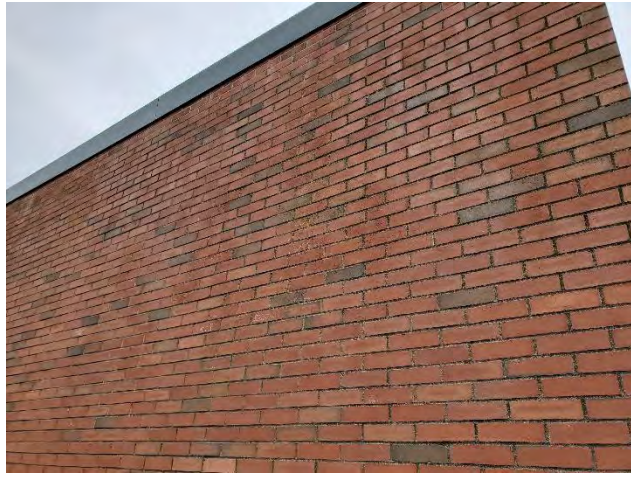
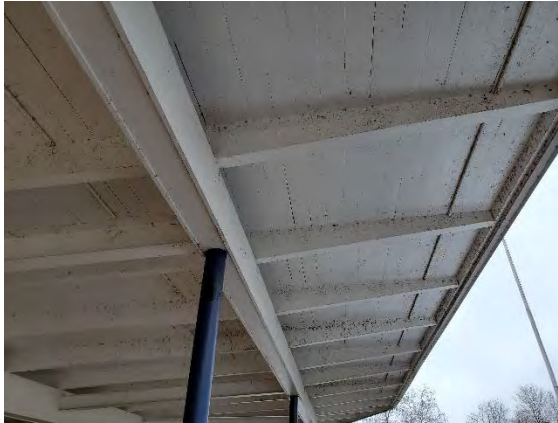
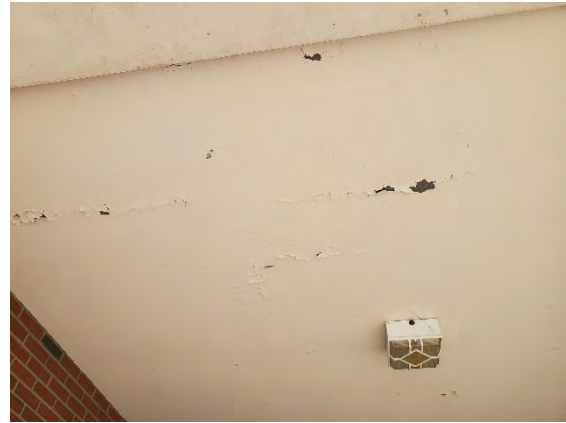
Exterior walls are primarily brick. Brick is in good to fair condition. Some areas need cleaning and repointing and can be corrected with ongoing maintenance.

Soffits are comprised of painted exterior grade sheathing and wood. The paint is failing in many areas.

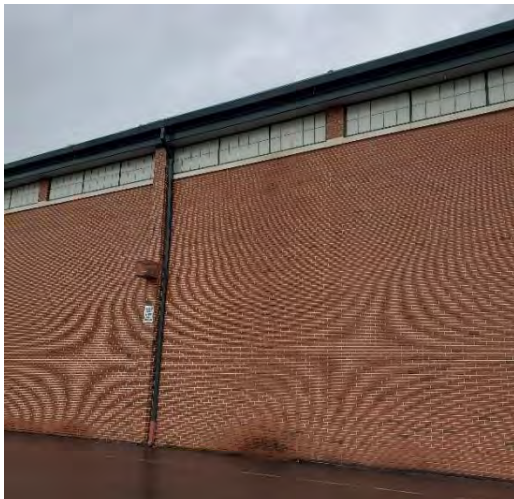
Roofing:

Roofing is built-up asphalt with some sections of metal roofing. Roofing is in good to fair condition. Leaking is reported from the gutters and downspouts surrounding the gymnasium roof. Additionally, the snow guard from this roof do not retain snow and ice adequately.

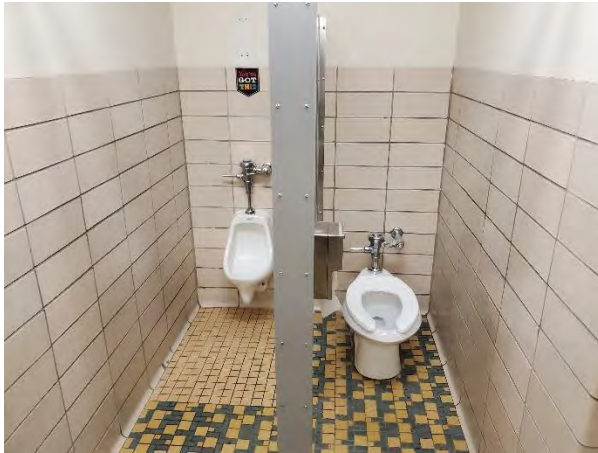
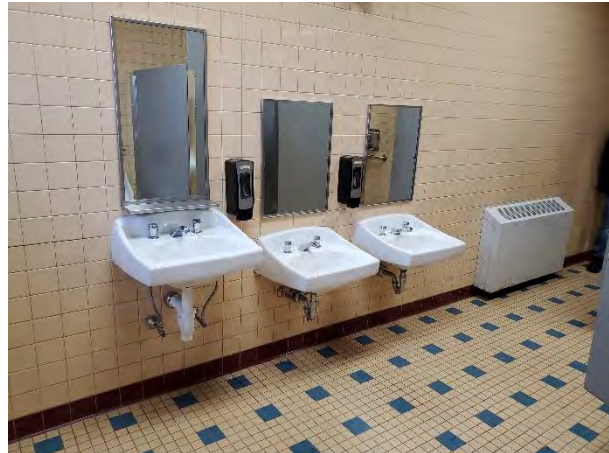
Toilet Rooms:

The majority of the toilet rooms are of adequate size and configuration. Some of the single occupancy toilet rooms in the classrooms do not meet required clearances for accessibility.

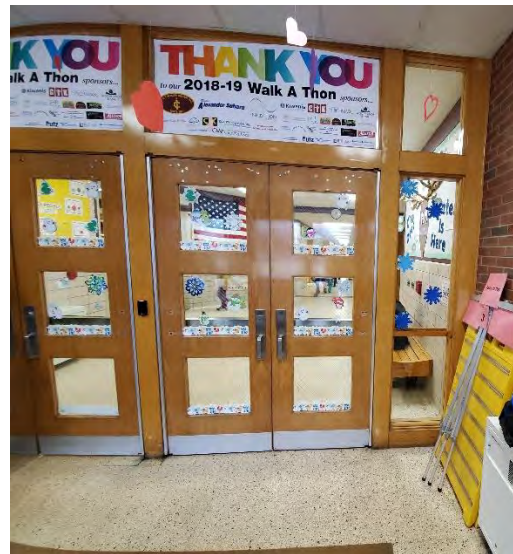
Doors:

Interior doors are a combination of wood with wood frames and wood with hollow metal frames. The doors and hardware are in fair to poor condition.

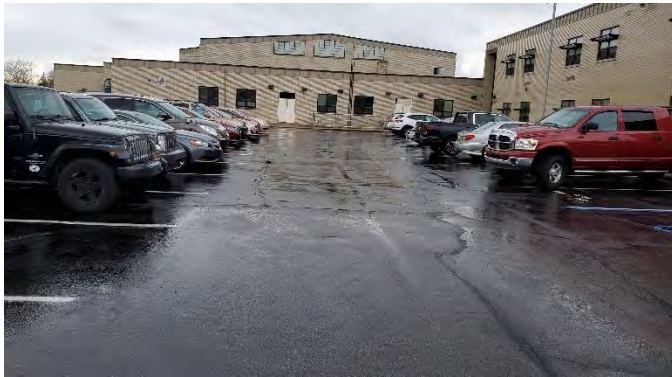
Paving & Walkways:

Drives and parking areas are bituminous, and sidewalks are concrete. Both are in fair condition with some areas of cracking. Ongoing maintenance is required.

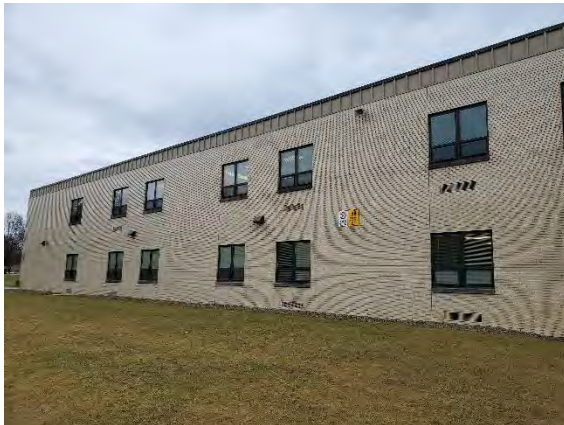
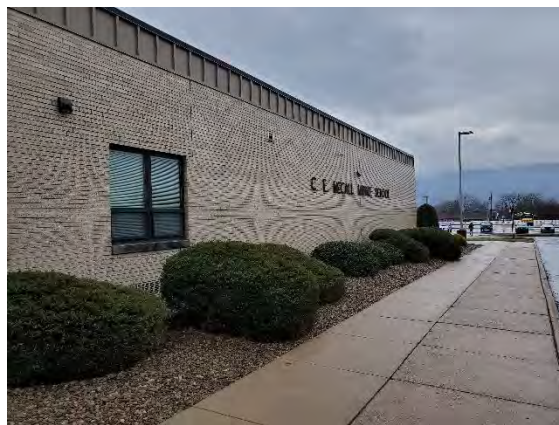
Exterior Walls:

Exterior walls are face brick. The brick is in good condition.

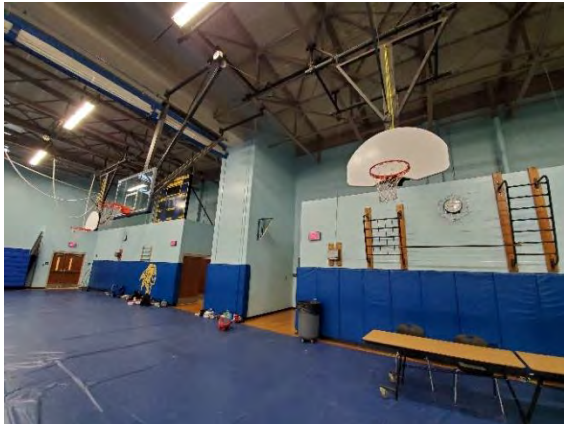
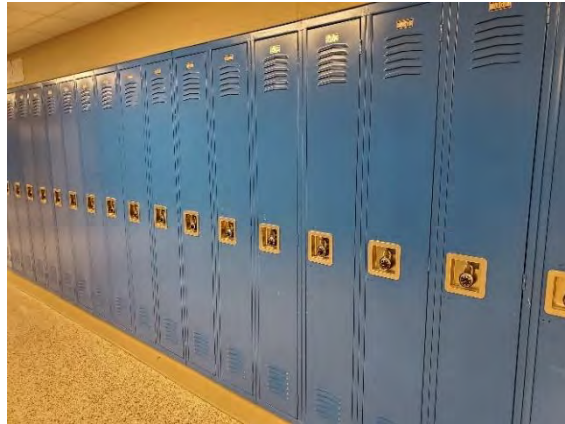
Specialty Equipment:

Food service and stage equipment is in good condition. Gymnasium equipment is outdated and nearing the end of its useful life. The TV studio equipment has failed and is in need of repair or replacement. Lockers are in poor condition.

- Replace ceramic tile in locker rooms.
- Replace gymnasium equipment.
- Replace TV studios AV equipment
- Refurbish or Replace student lockers

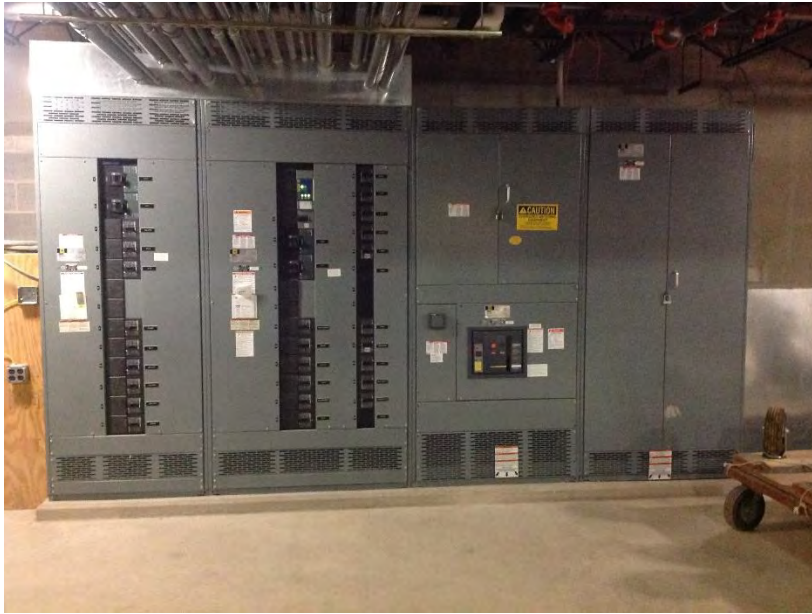
The High School is served by a 480/277 volt, 3 phase, 4 wire 2500 amp main distribution switchboard (MDS). Branch devices are circuit breakers. The unit was installed during the 2012 renovation. Spare breakers and space are available. Typical usable life for this type of switchboard is 30-40 years. The MDS is fed from an outdoor pad mounted transformer. The MDS feeds various building 480V distribution equipment via conduit and wire feeders. Branch circuit panels were in good condition and have spare circuits available.

Switchboard

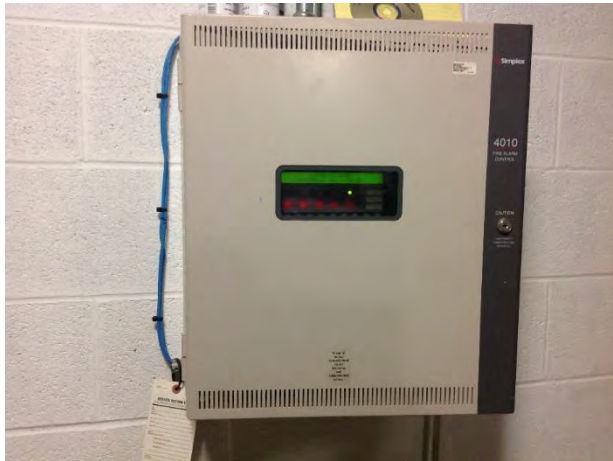
The main building is served by a Simplex 4010 fire alarm system installed during the 2012 renovations/additions in good condition. Note that any additions/alterations to the building may require an upgrade to this panel/system due to current code requirements of voice notification systems.

Fire Alarm Panel

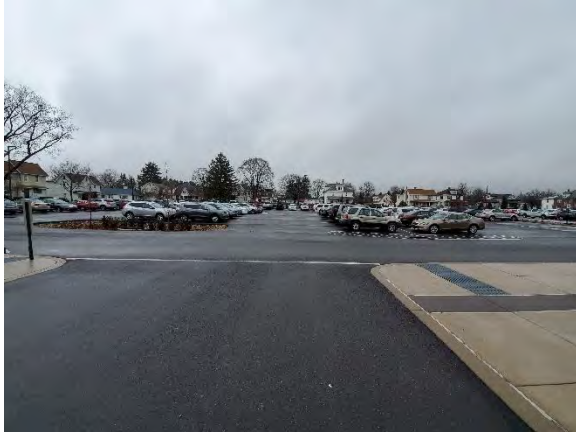
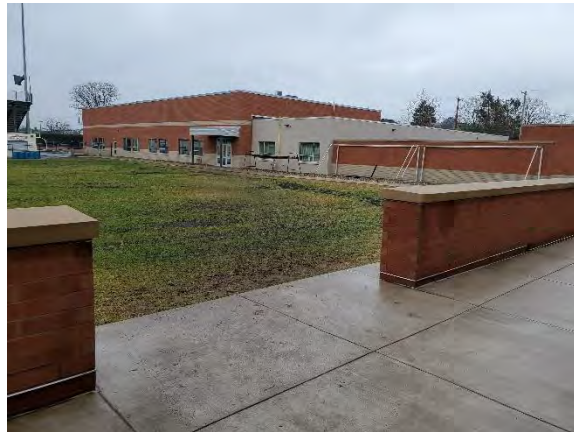
A section of grass area between the main building and the Tech Ed building is wearing due to student traffic. Traffic can be diverted to avoid this.

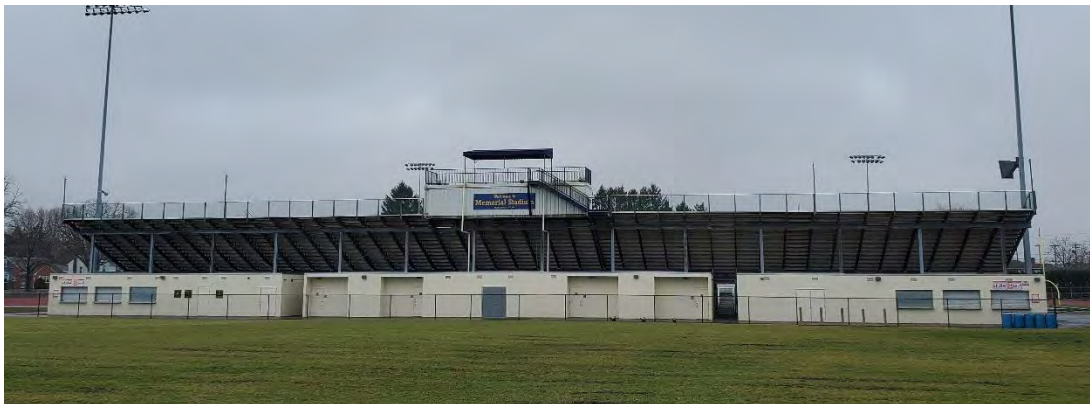
Athletic Fields:

A stadium with a synthetic turf field and synthetic running track exists on the property. The field and track are in good condition. Aluminum bleachers are used for spectator seating. The aluminum bleachers are in good condition. A concrete masonry structure exists under the bleachers and contains space for toilet rooms, storage, and concessions. This building is in fair condition.

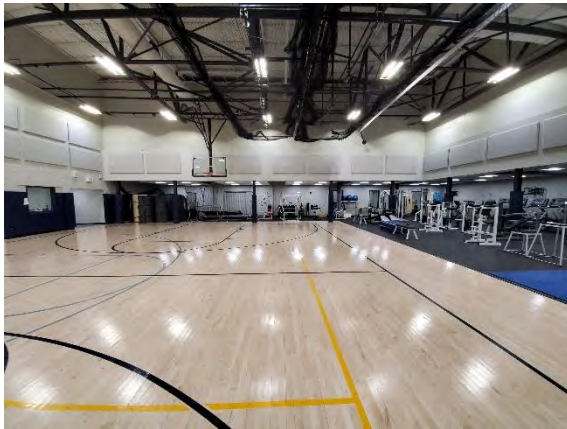
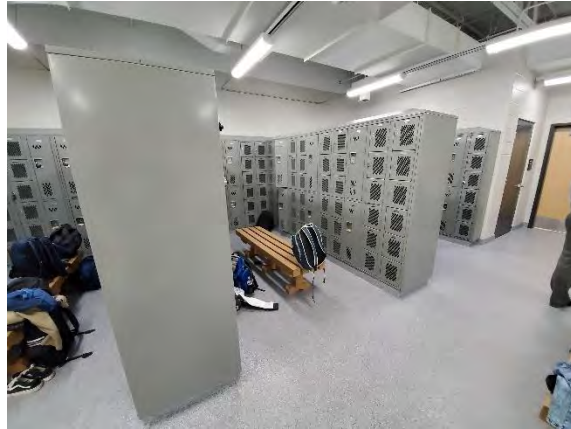
Food Service, Auditorium/Stage, Gymnasium equipment is up to date and in good condition. Lockers are also in good condition.

- Paint main gymnasium.
- Re-seal auditorium flooring or install VCT flooring.

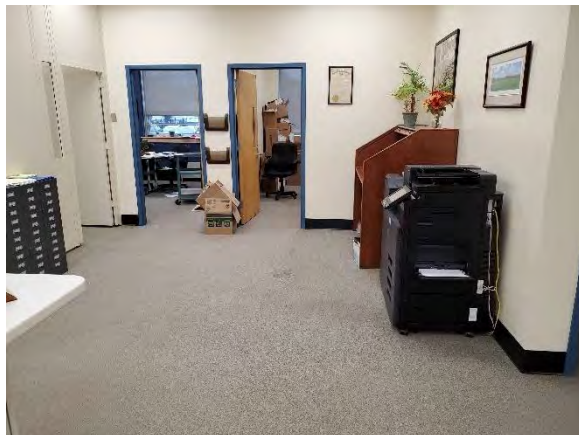
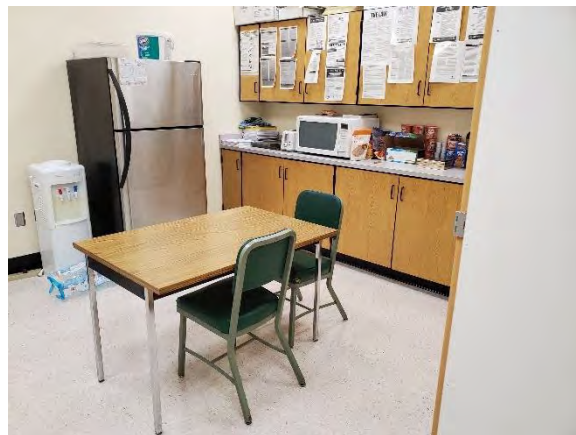
Flooring is carpet and VCT. Flooring is in poor condition. Walls are painted gypsum wallboard and are in fair condition. Ceilings are acoustical tile and are in good to fair condition.
