FACILITY CONDITION ASSESSMENT

MONTOURSVILE AREA SCHOOL DISTRICT

Montoursville Area School District:
Loyalsock Valley Elementary School
Lyter Elementary School

JUNE 2024

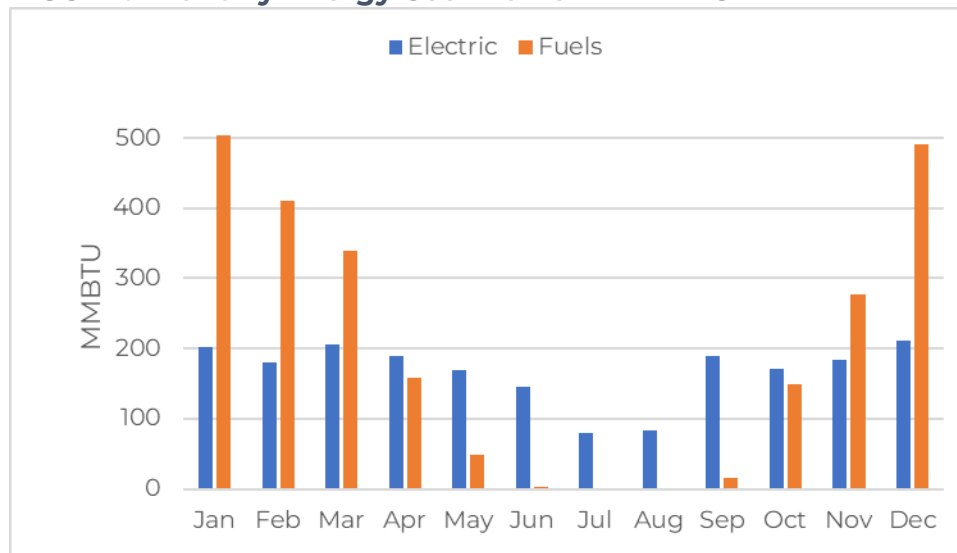
FIGURE: Monthly Energy Use Profile in MMBTU

The following figures show the monthly use and cost profile of the same data aggregated for all buildings.

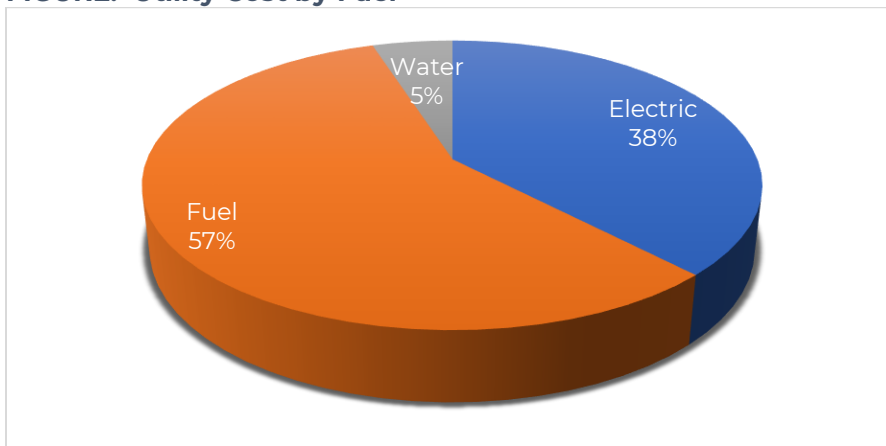
FIGURE: Utility Cost by Fuel

Fuels is the largest component of the District's utility expenditures for the Elementary Buildings, accounting for 57% of the energy costs included in this assessment.

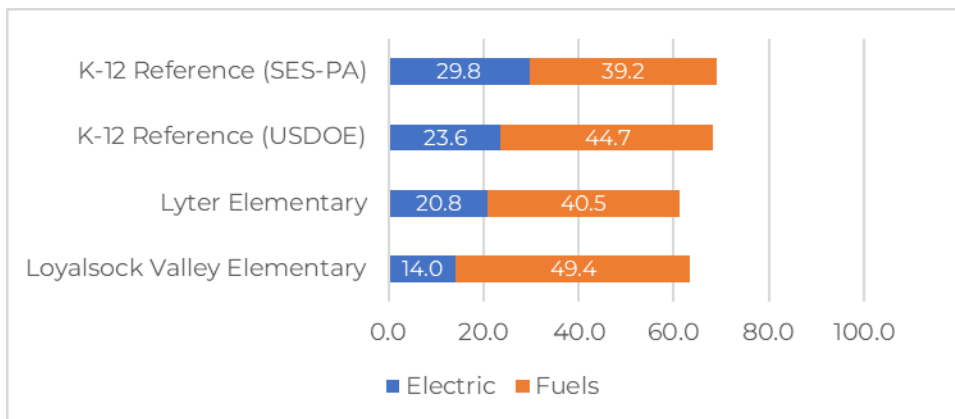
FIGURE: Energy Indices by Building

The following figure shows the energy intensity of the buildings energy as compared to the reference indices (U.S. Department of Energy 2012 CBECS data and SitelogIQ's Pennsylvania K-12 database).

Notice buildings for the reference benchmarked have 100% cooling capacity, which represent an increased electrical use. As expected, Lyter and Loyalsock Valley Elementary Schools EUI for electric is lower than the K-12 reference.

Loyalsock Valley Elementary has an overall EUI above the reference benchmark due to the higher EUI for Heating Fuel of 56.2 kBTU/sf-yr. The heating system for this building should be further evaluated – the cost of fuel oil makes up 73% of the overall operation cost of the building (excluding sewer costs).

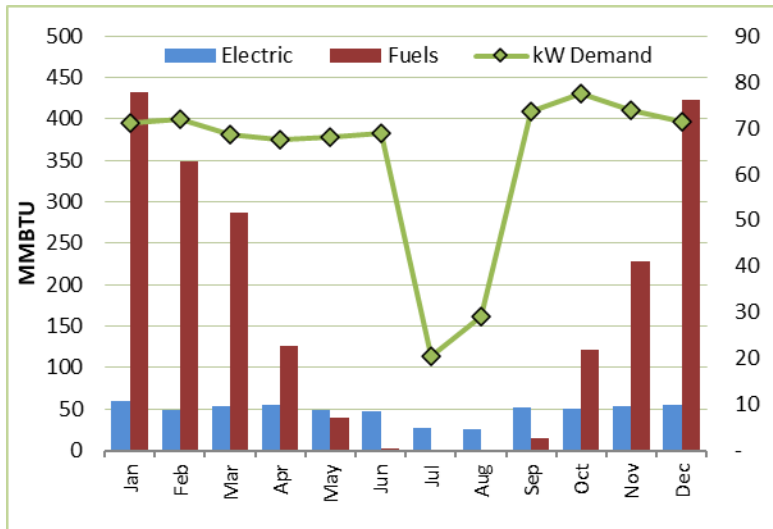
Loyalsock Valley Elementary

*Fuel Oil for Loyalsock is billed per delivery date, the data was normalized based on weather data to calculate monthly consumption over the two-year period.
